**Costly Problem, Simple Solution –
If You Use It**

**Is Your Independent Second
Check Done Right?**

FATHOM

The Naval Safety Center's Afloat Magazine October-December 1999

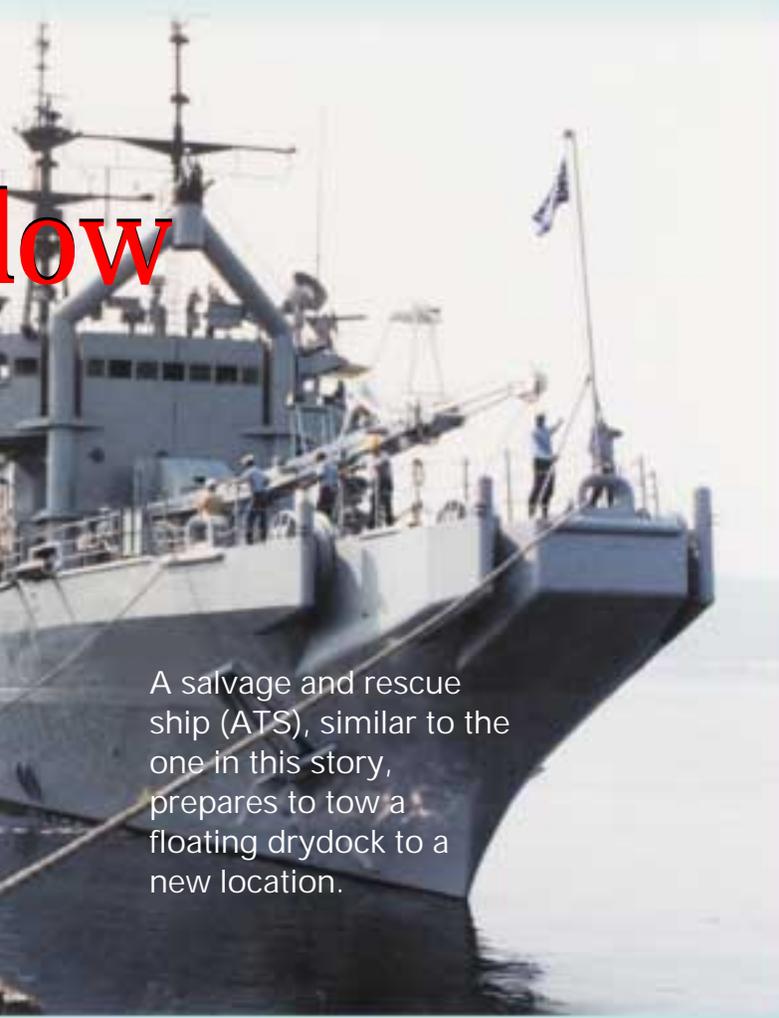
A salvage and rescue ship (ATS), similar to the one in this story, prepares to tow a floating drydock to a new location.

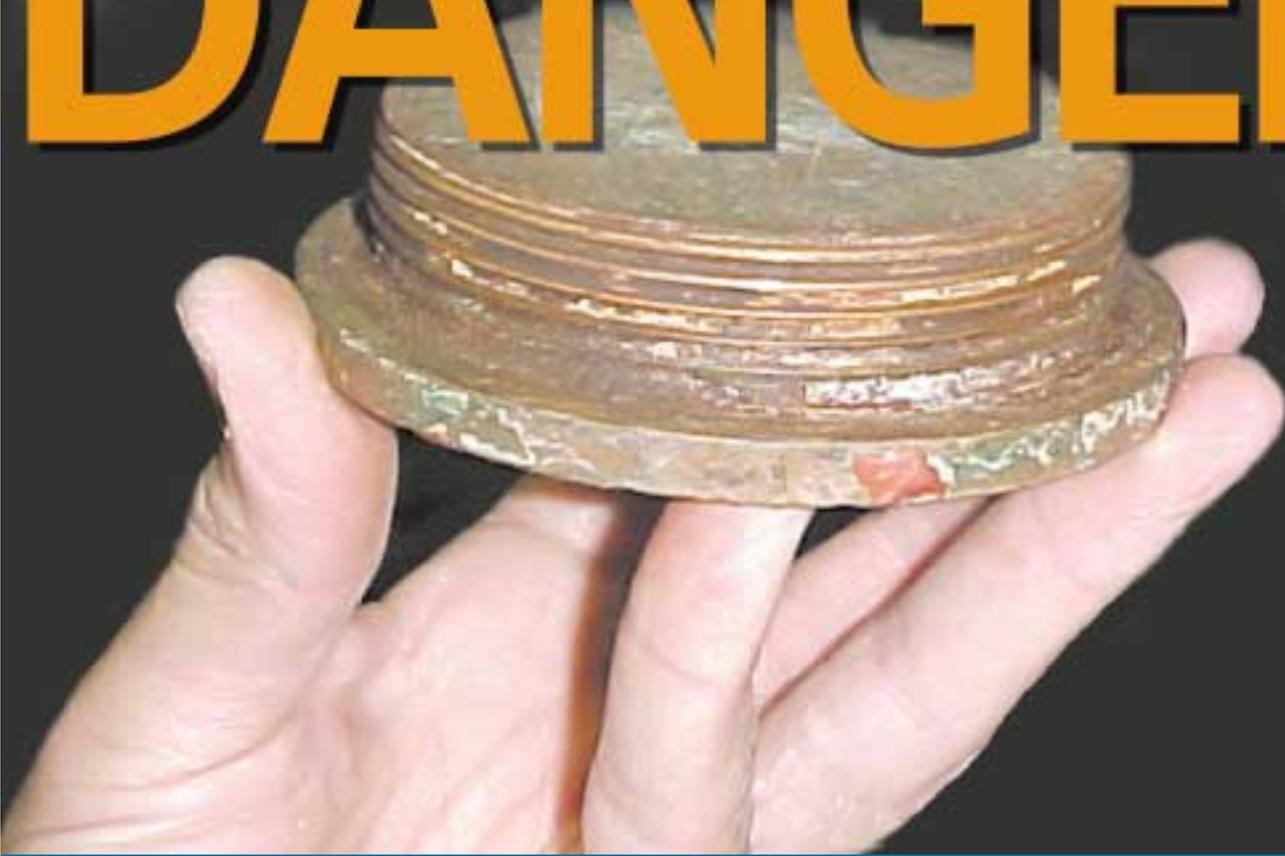
Worn threads on a sounding-tube cap figured into a mishap. Would you want to trust the threads on this cap? Not if you're smart.

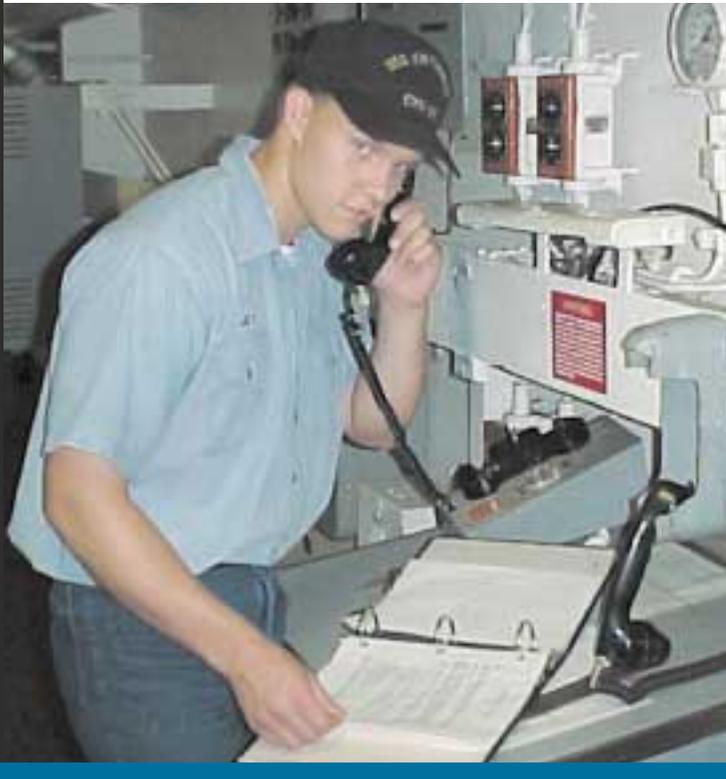
(Below) A maintenance man verifies procedures and compares valve numbers with damage-control central. If the top watch in this story had done the same thing with the manifold operator, the ending could have been different.

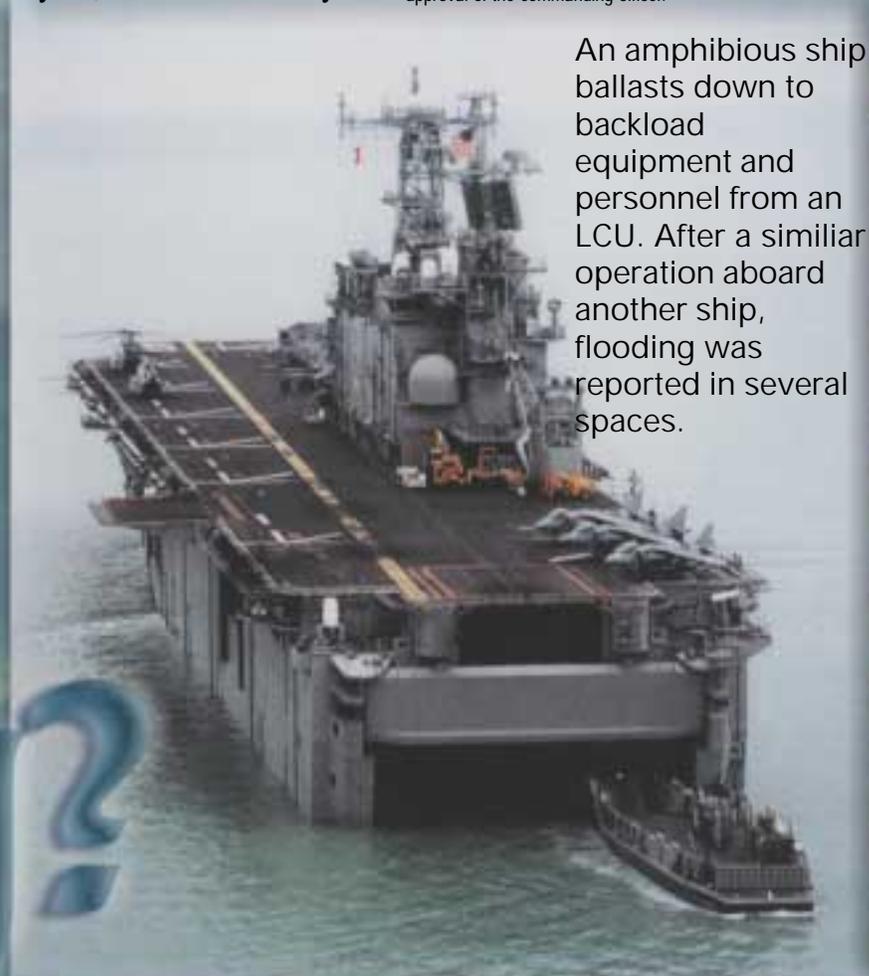
An amphibious ship ballasts down to backload equipment and personnel from an LCU. After a similiar operation aboard another ship, flooding was reported in several spaces.

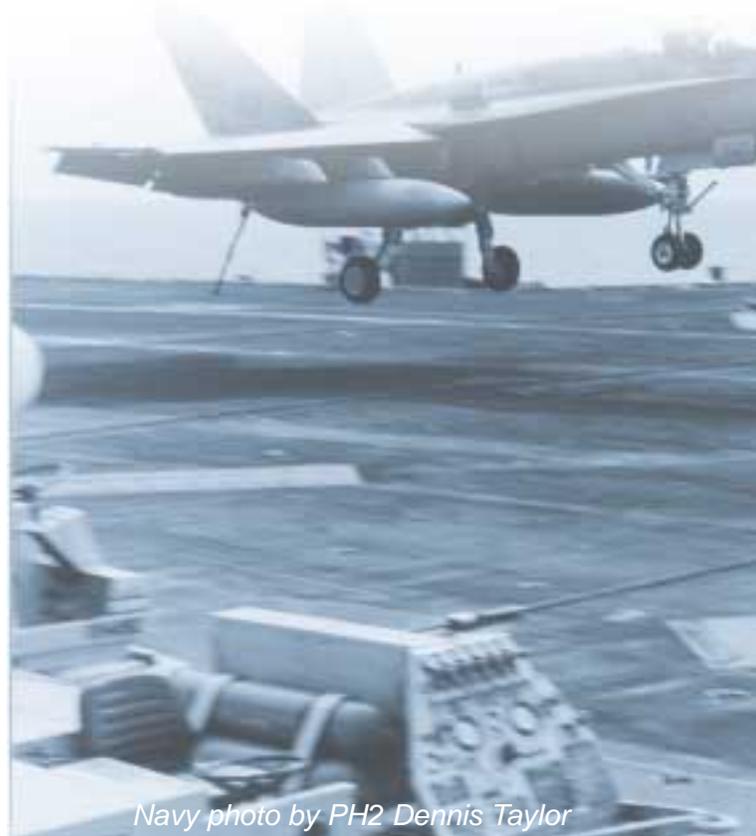
When a modern aircraft like this FA-18 crashes, recovery personnel have to handle pieces of the wreckage carefully. The graphite and boron fibers used in the aircraft's components are so fine they can penetrate your skin without causing any sensation.

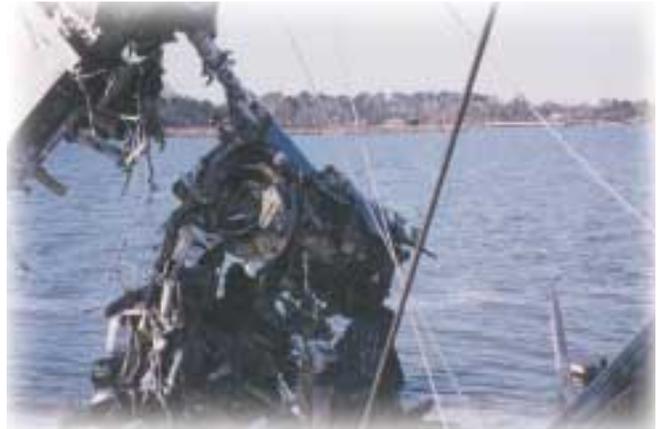
Shipboard personnel recover the twisted wreckage of a downed F-14.

Although the chance of finding ordnance that was attached to the aircraft is rare, ejection seats and their explosive charges have been known to float. Any ordnance you find may be unstable and, therefore, dangerous. If EOD technicians are aboard, have them safe the seat; if there aren't any aboard, store the seat in a safe location until experts can take care of it.

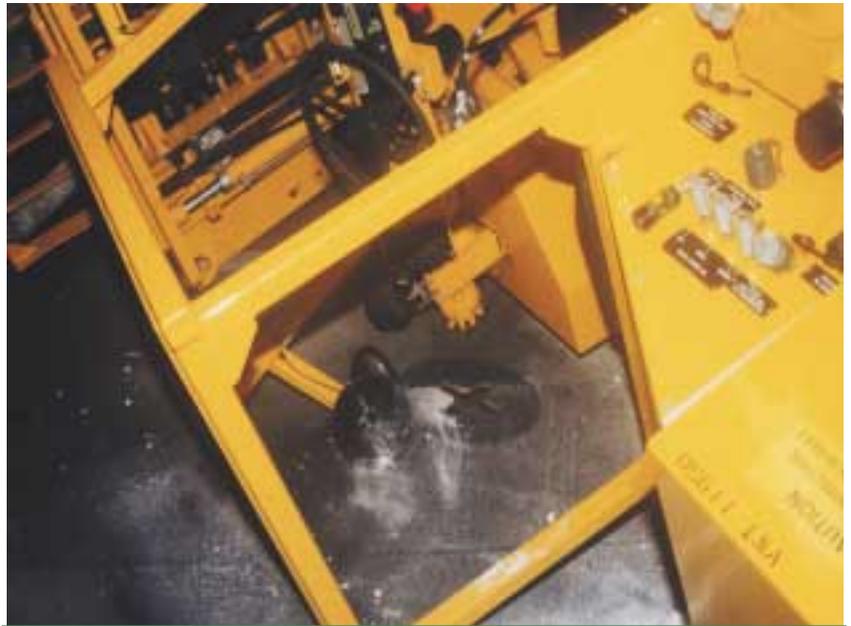
This is how the second PO3's forklift looked after it had fallen on its left side.

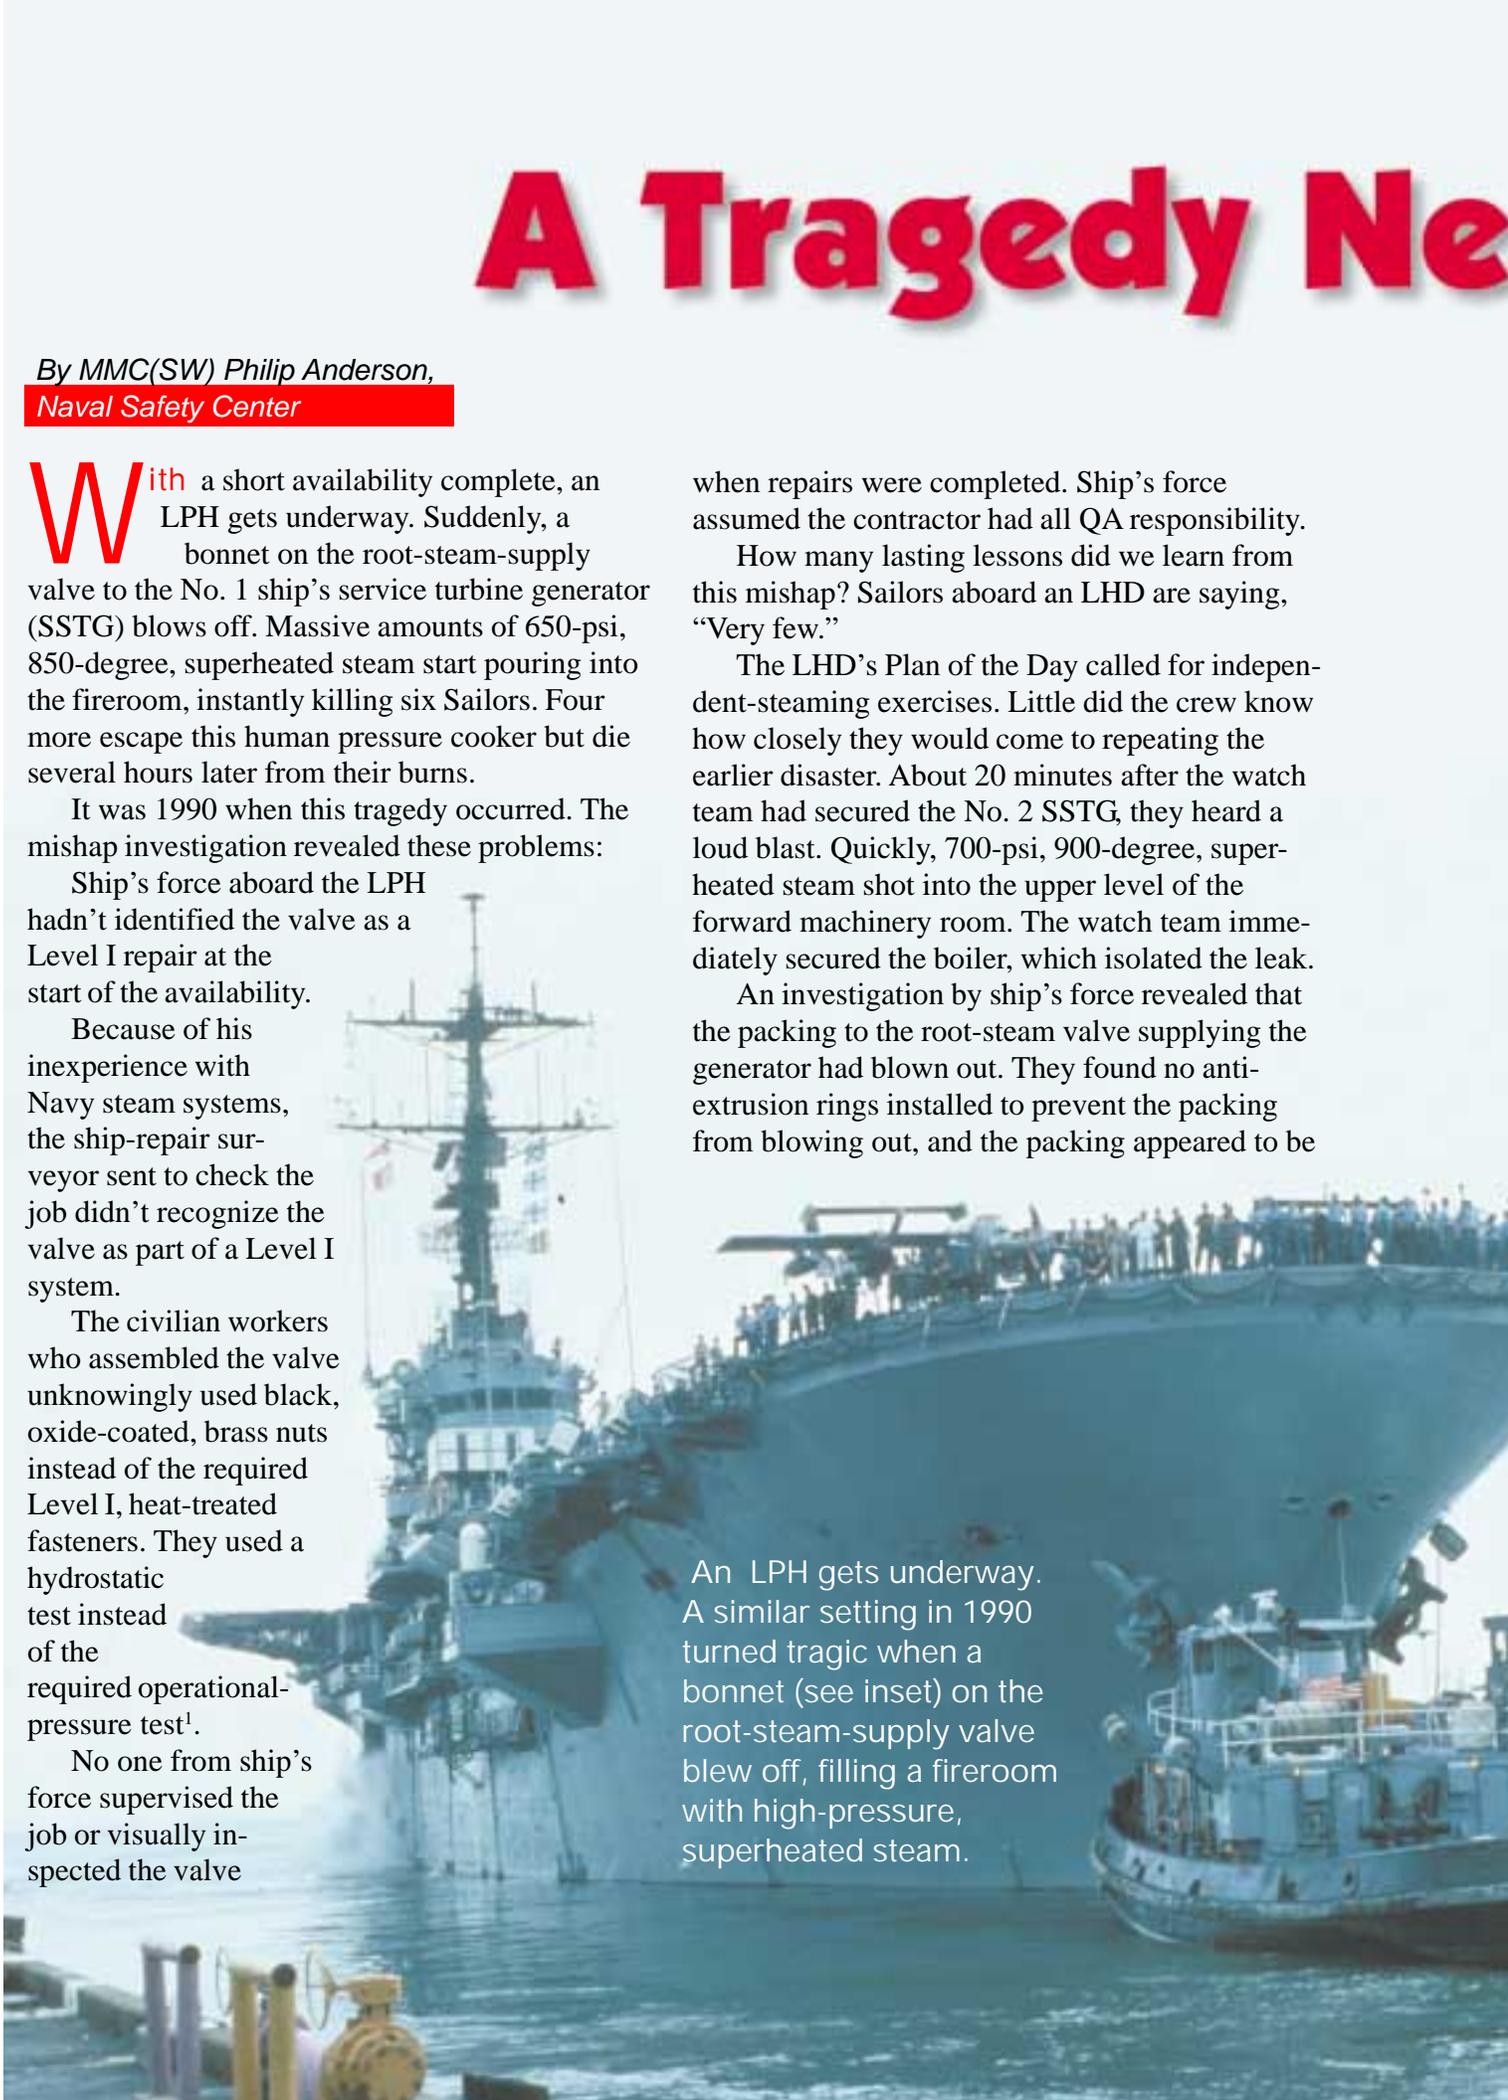
An LPH gets underway. A similar setting in 1990 turned tragic when a bonnet (see inset) on the root-steam-supply valve blew off, filling a fireroom with high-pressure, superheated steam.

An investigation by ship's force revealed that the packing to the root-steam valve supplying the generator had blown out. They found no anti-extrusion rings installed to prevent the packing from blowing out, and the packing appeared to be

the wrong type of material. Contractors recently had overhauled this valve and, according to ship's force, had the responsibility for quality assurance.
